**Flood Control Project Maintenance  
Levee Inspections**  
**LMA District Cover Sheet**  
**Spring 2011 Levee Inspection Results**

**Merced Streams Group**

**Levee Inspection Report By Mile - Spring 2011**

Waterway						Bank	Unit Miles	Inspection Start/End	Inspector
Unit No. 01 Black Rascal Diversion						Right	1.64	05/05/2011 05/05/2011	Herman Phillips

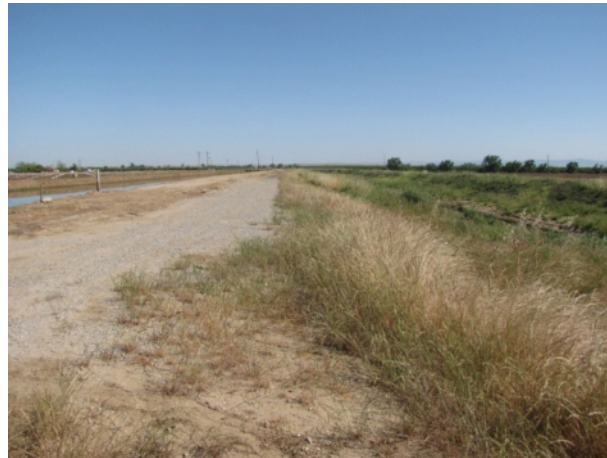
Levee Mile Report Line	1
Start Levee Mile	0.00
End Levee Mile	0.03
Location	Water Side
Category	Earthen Levee
Item	Vegetation

Standing at levee mile 0.00 looking downstream of Black Rascal Creek waterside. 5-4-2011

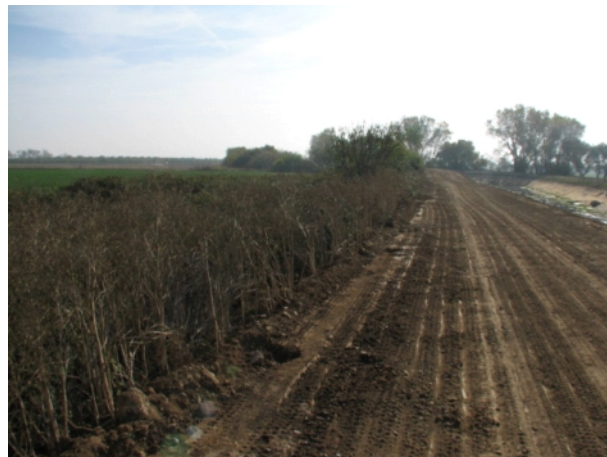
Levee Mile Report Line	3
Start Levee Mile	1.31
End Levee Mile	1.63
Location	Water Side
Category	Earthen Levee
Item	Vegetation

Blackberries and dense brush obstruct access and visibility of top 20' of waterside slope. Photo looking downstream. MID canal on right.

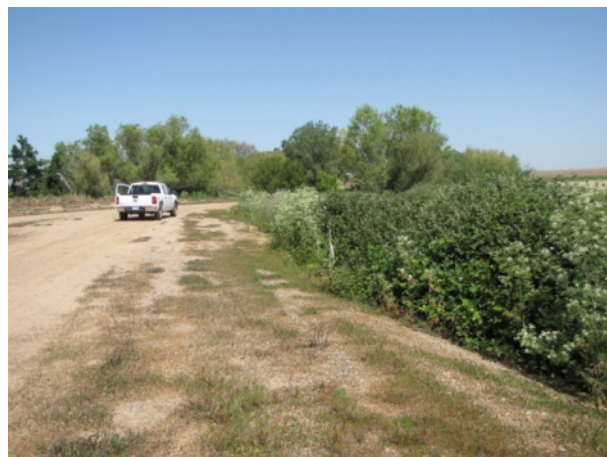
Levee Mile Report Line	3
Start Levee Mile	1.31
End Levee Mile	1.63
Location	Water Side
Category	Earthen Levee
Item	Vegetation

Looking downstream at vegetation on waterward the top 20-feet over grown levee mile 1.33-1.64. Photo taken 5-4-2011.

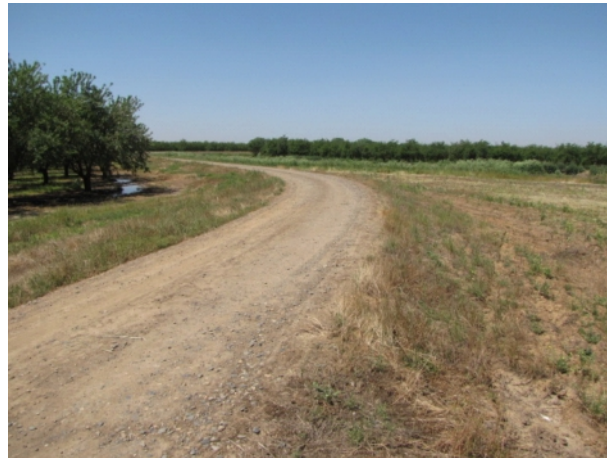
Levee Mile Report Line	1
Start Levee Mile	0.00
End Levee Mile	0.00
Location	Land Side
Category	Earthen Levee
Item	Vegetation

Levee mile 0.00 looking downstream Unit 2. 5-4-2011

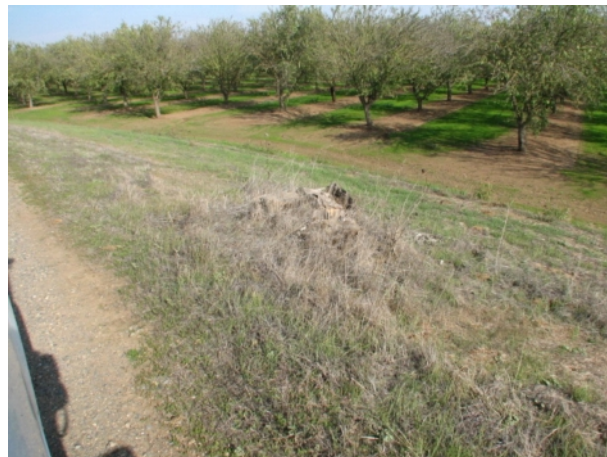
Levee Mile Report Line	3
Start Levee Mile	0.44
End Levee Mile	0.44
Location	Land Side
Category	Earthen Levee
Item	Trim / Thin Trees

Large tree stump on levee slope.

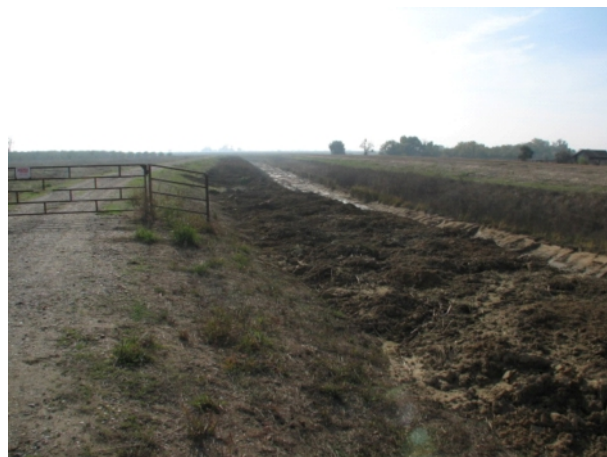
Levee Mile Report Line	4
Start Levee Mile	0.53
End Levee Mile	1.67
Location	Water Side
Category	Channels
Item	Encroachments

Dredge material placed on berm of diversion channel.

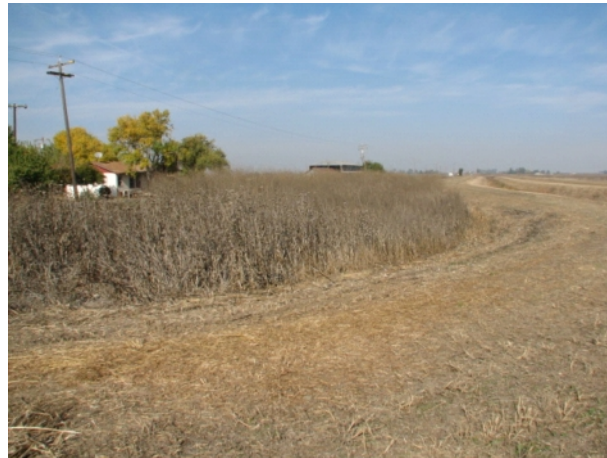
Levee Mile Report Line	3
Start Levee Mile	0.01
End Levee Mile	0.01
Location	Land Side
Category	Earthen Levee
Item	Vegetation
Tall thistle within 10' of landside toe obstructs access and visibility.	
phillips_s_20110228_180.jpg

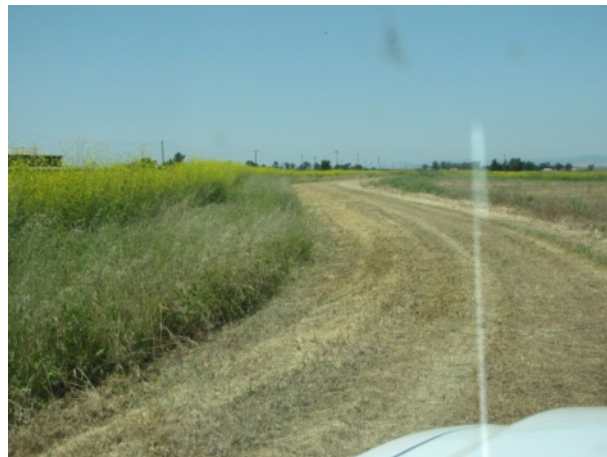
Levee Mile Report Line	3
Start Levee Mile	0.01
End Levee Mile	0.01
Location	Land Side
Category	Earthen Levee
Item	Vegetation
The area hasn't changed much since last inspection. Tall thistle and mustards within 10' of landside toe. 5-4-2011	
phillips_s_20110511_307.jpg

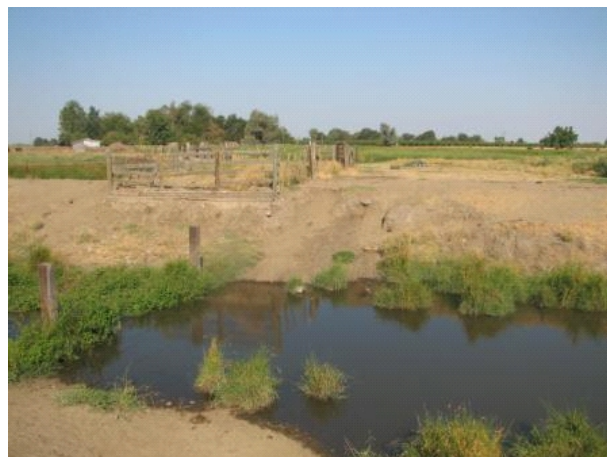
Levee Mile Report Line	11
Start Levee Mile	1.00
End Levee Mile	1.00
Location	Water Side
Category	Supplemental
Item	DWR Erosion Survey
Photo taken in 2008.	
phillips_s_20110228_174.jpg

11	1.00	1.00	Supplemental	DWR Erosion Survey	WS	U	Inspector Comments: 11/30/2010: Site was not inspected this year due to time constraint. There have been no reports from the district that this site was corrected. Continue to monitor during flood events. [2010 SiteID: NA0013U03RM1]	37.270800 ° -120.284180 °	37.270800 ° -120.284180 °	2 Y
12	1.15	1.15	Earthen Levee	Animal Control	LS	M	Exterminate rodents and backfill and compact or grout burrows.	37.272036 ° -120.282111 °	37.272036 ° -120.282111 °	15
13	1.20	1.20	Earthen Levee	Animal Control	LS	M	Exterminate rodents and backfill and compact or grout burrows.	37.272444 ° -120.281282 °	37.272444 ° -120.281282 °	970
14	1.23	1.23	Earthen Levee	Animal Control	CR	M	Exterminate rodents and backfill and compact or grout burrows.	37.272553 ° -120.280742 °	37.272553 ° -120.280742 °	971
15	1.24	1.24	Earthen Levee	Animal Control	CR	M	Exterminate rodents and backfill and compact or grout burrows. Inspector Comments: This Unit is maintained as far as the vegetation is concerned however there is a problem with the rodents. The District should have bait stations through out the area where rodents are present.	37.272584 ° -120.280543 °	37.272584 ° -120.280543 °	8

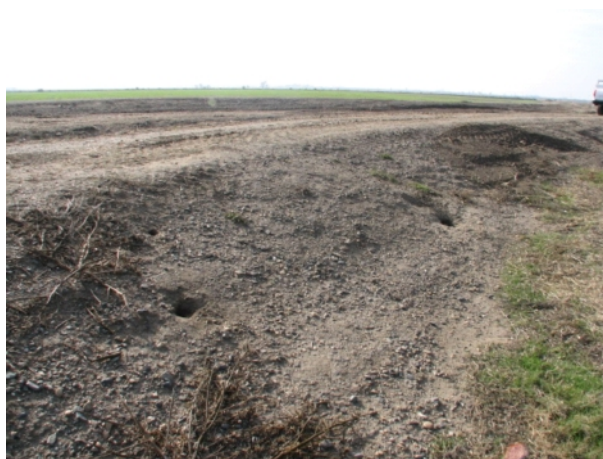
Levee Mile Report Line	16
Start Levee Mile	1.25
End Levee Mile	1.25
Location	Land Side
Category	Earthen Levee
Item	Animal Control

16	1.25	1.25	Earthen Levee	Animal Control	LS	M	Exterminate rodents and backfill and compact or grout burrows.	37.272707 ° -120.280334 °	37.272707 ° -120.280334 °	7 Y

Active animal burrows on levee slope and toe.

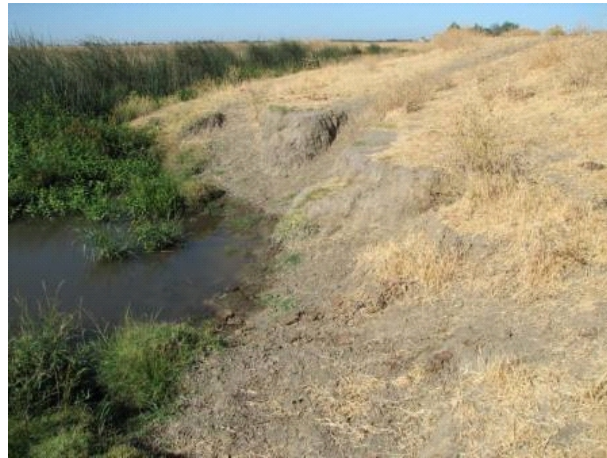
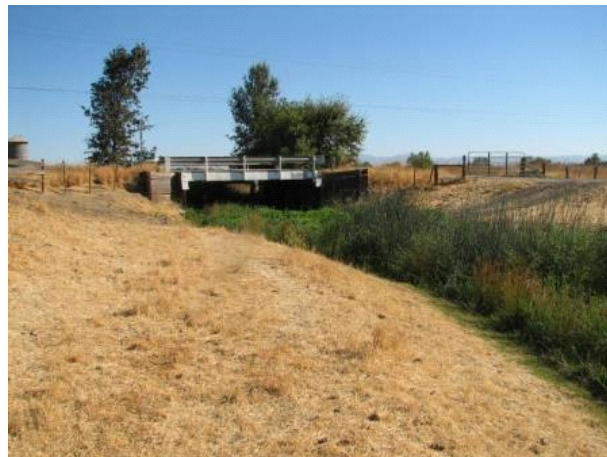
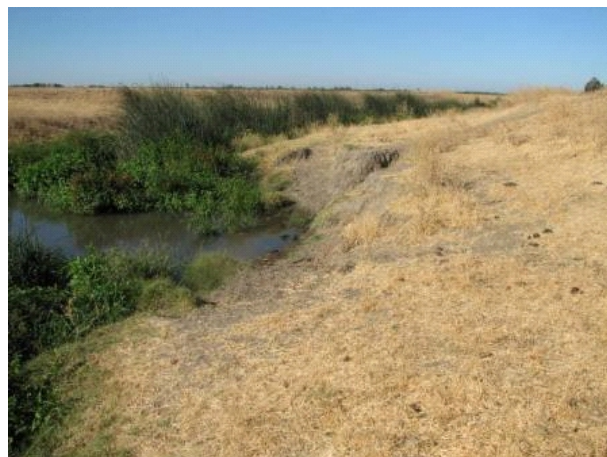
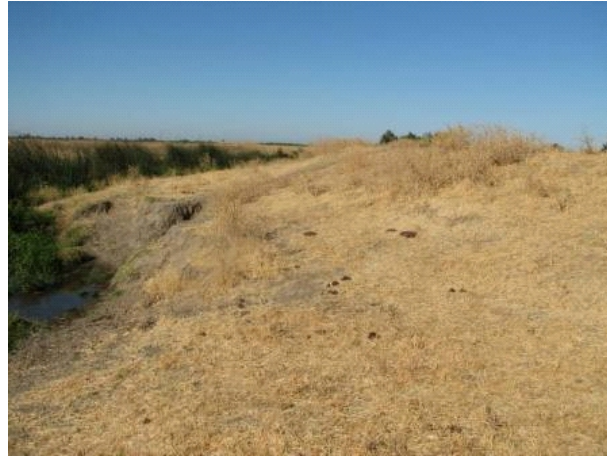
LMR No.	Levee Mile		Category	Item	* Location	** Rating	Action/Comment	GPS Latitude/Longitude		Issue No.
	Start	End						Start	End	Photo
17	1.25	1.25	Supplemental	DWR Erosion Survey	WS	M	Inspector Comments: 11/30/2010: Site was not inspected this year due to time constraint. There have been no reports from the district that the site. Continue to monitor during flood events. [2010 SiteID: NA0013U03RM1.25]	37.272630 ° -120.280390 °	37.272630 ° -120.280390 °	1 Y
18	1.27	1.27	Earthen Levee	Trim / Thin Trees	LS	M	Trim trees to at least five feet above ground level.	37.272866 ° -120.280295 °	37.272866 ° -120.280295 °	13
19	1.32	1.32	Earthen Levee	Trim / Thin Trees	WS	M	Trim trees to at least five feet above ground level.	37.273454 ° -120.279891 °	37.273454 ° -120.279891 °	4 Y

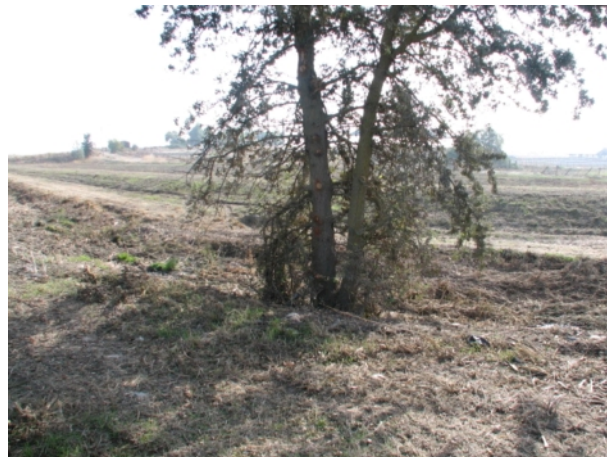
Levee Mile Report Line	19
Start Levee Mile	1.32
End Levee Mile	1.32
Location	Water Side
Category	Earthen Levee
Item	Trim / Thin Trees

Tree on levee slope should be trimmed up 5' to improve visibility.

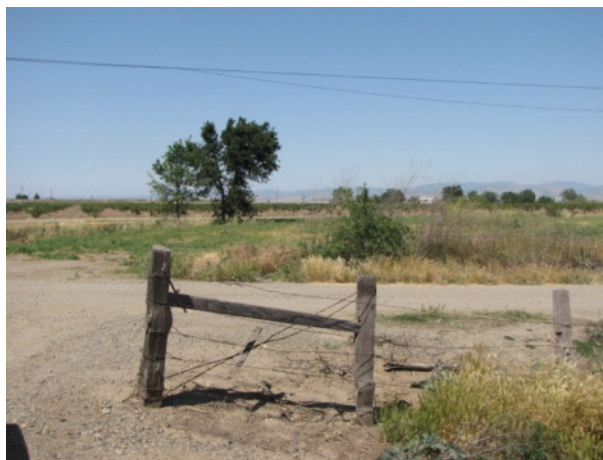
Standing off Mission Avenue Levee mile 0.13 looking upstream unit 4. 5-4-2011

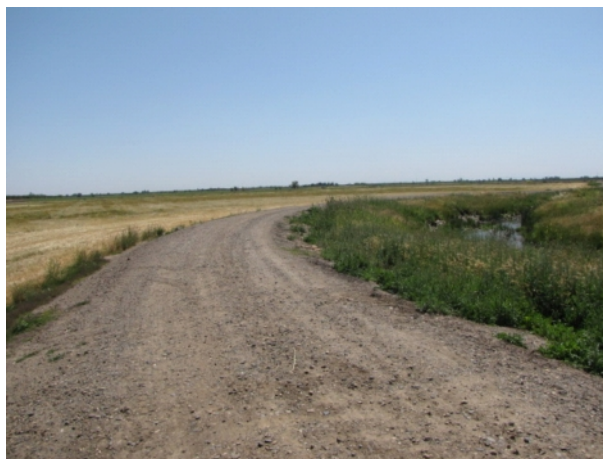
Levee Mile Report Line	3
Start Levee Mile	0.13
End Levee Mile	0.13
Location	Water Side
Category	Earthen Levee
Item	Vegetation

Looking downstream from levee 0.13 Unit 4. 5-4-2011

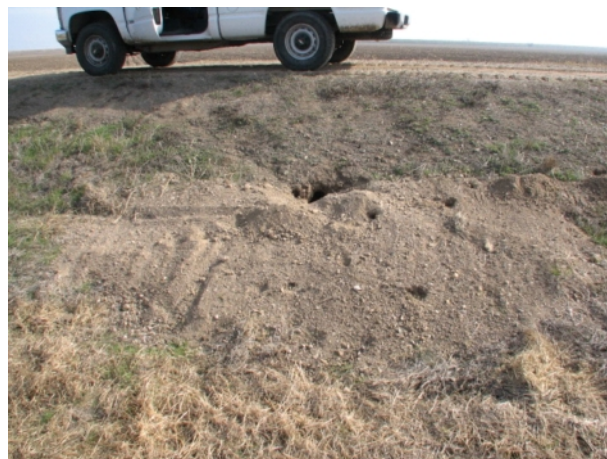
Levee Mile Report Line	14
Start Levee Mile	0.65
End Levee Mile	0.65
Location	Water Side
Category	Earthen Levee
Item	Animal Control

Active animal burrows on levee slope.

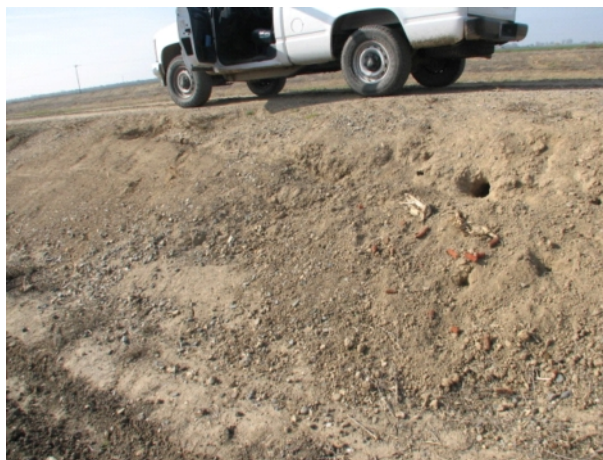
Active animal burrows on levee slope.

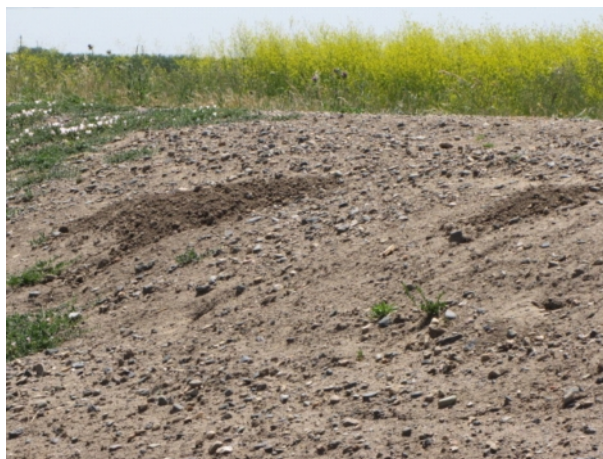
Levee Mile Report Line	16
Start Levee Mile	0.72
End Levee Mile	0.72
Location	Land Side
Category	Earthen Levee
Item	Animal Control

Active animal burrows on levee slope. 5-4-2011.

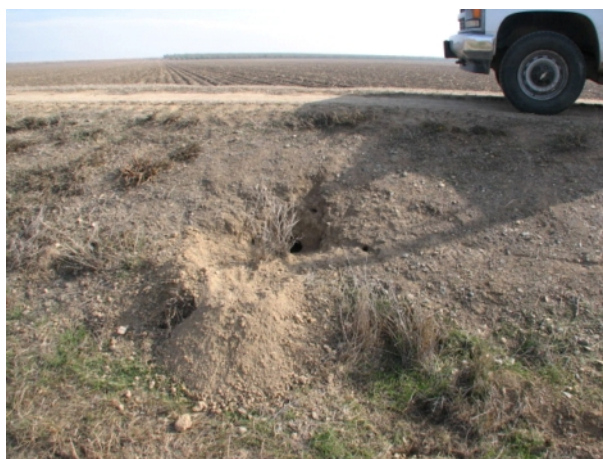
Levee Mile Report Line	17
Start Levee Mile	0.73
End Levee Mile	0.73
Location	Water Side
Category	Earthen Levee
Item	Animal Control

Active animal burrows on levee slope.

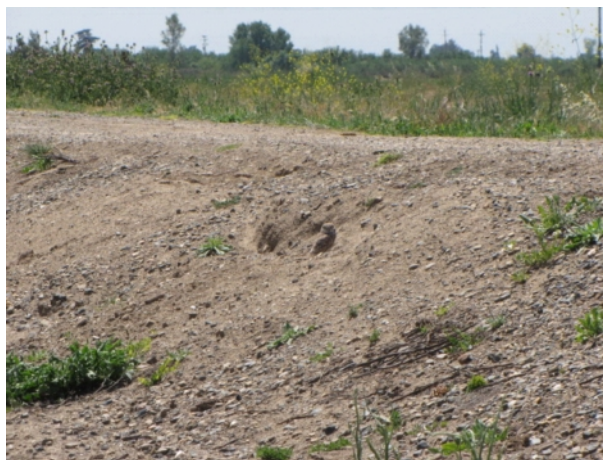
Active animal burrows on levee slopes. 5-4-2011

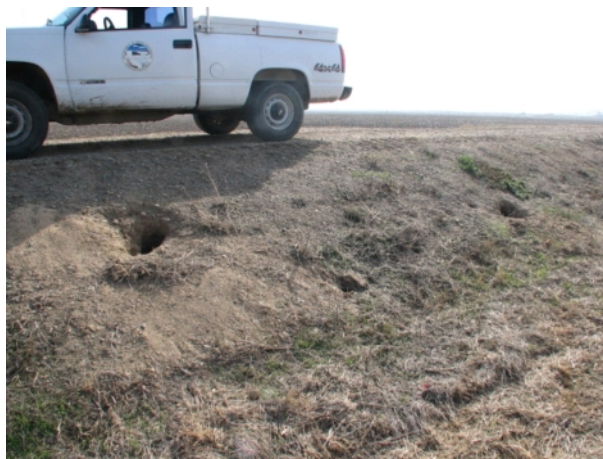
Levee Mile Report Line	18
Start Levee Mile	0.75
End Levee Mile	0.75
Location	Water Side
Category	Earthen Levee
Item	Animal Control

Active animal burrows on levee slope.

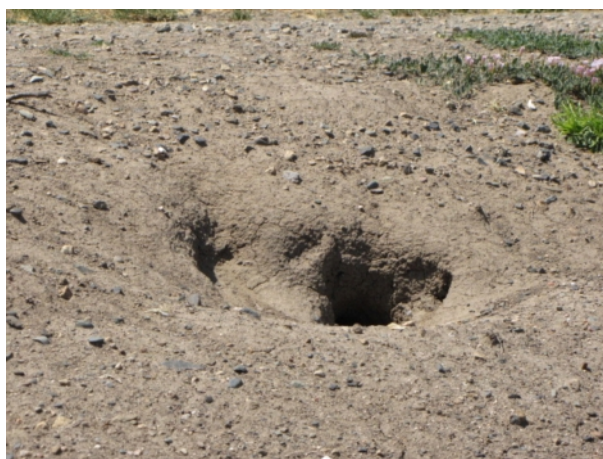
Levee Mile Report Line	18
Start Levee Mile	0.75
End Levee Mile	0.75
Location	Water Side
Category	Earthen Levee
Item	Animal Control

Active animal borrows on levee slope. 5-4-2011

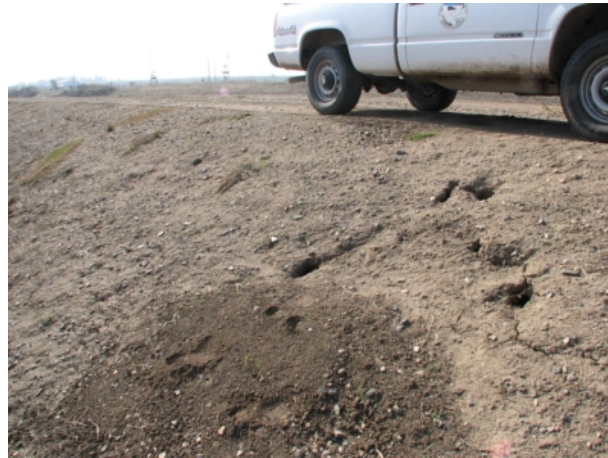
Active animal burrows on levee slope.

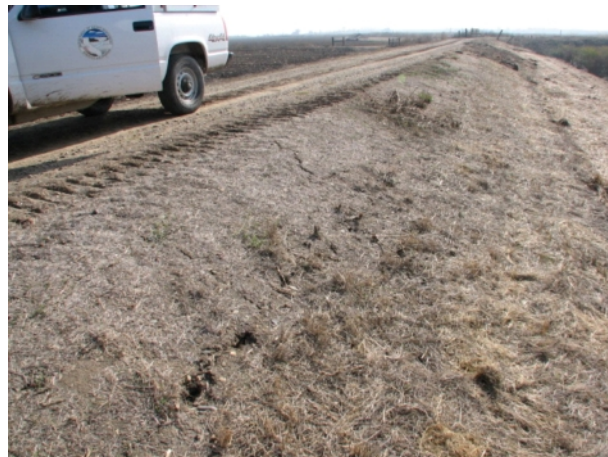
Levee Mile Report Line	27
Start Levee Mile	0.97
End Levee Mile	0.97
Location	Water Side
Category	Earthen Levee
Item	Cracking

Minor surface cracking on waterside levee slope.
